exterior conditions

DESCRIPTION & ANALYSIS

FINDINGS & ASSESSMENT

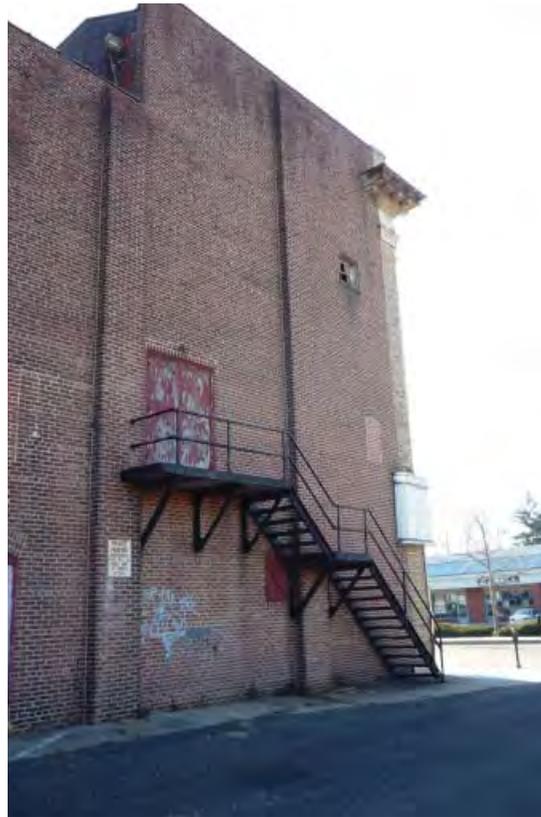
Emergency exits are rusted out and have become unsafe for use.

- 3. Sides and Rear:** Damaged brick is to be removed and replaced with matching brick; joints to be raked and repointed with Portland cement mortar to match as close as possible to the existing mortar, downspouts to be replaced with a dark brown color. Emergency exits should comply with current codes and be rebuilt. New windows must be installed.

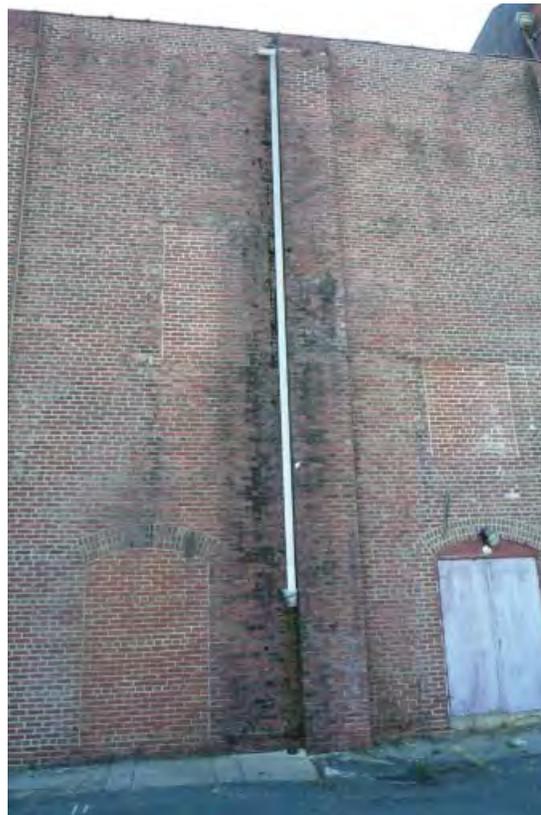
The west elevation has several issues. This picture represents missing downspout which is destroying the brick face.

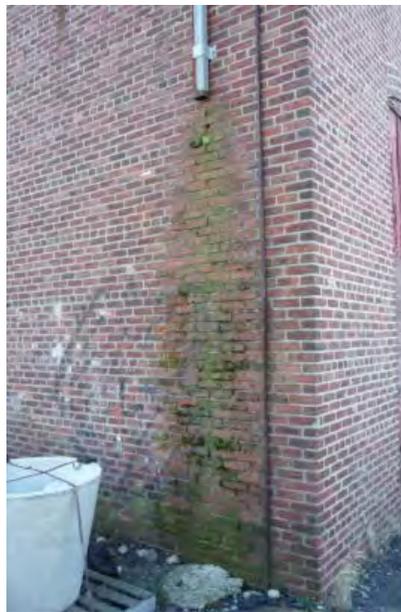
The rear elevation has a slight bow. Refer to structural report.

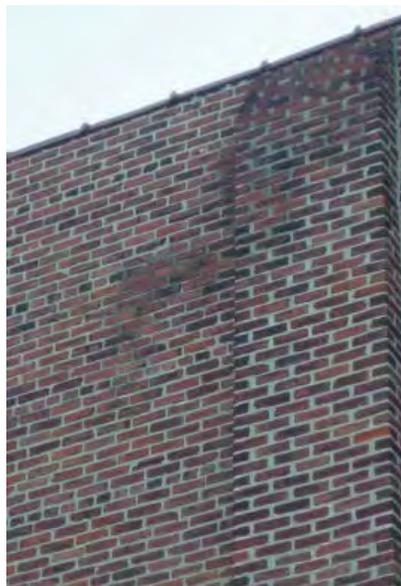
The north elevation or rear also has a missing portion of a downspout which is rapidly deteriorating the masonry.

Masonry stains are tell tale signs of water penetration from the roof area.

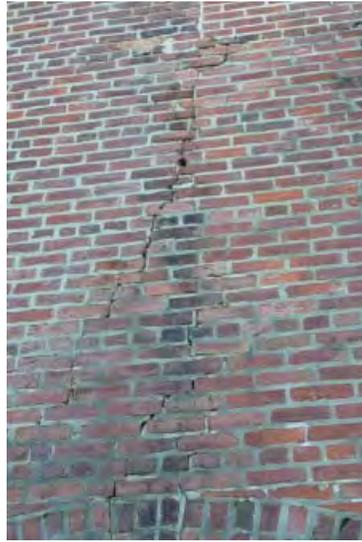
East elevation
masonry cracks.

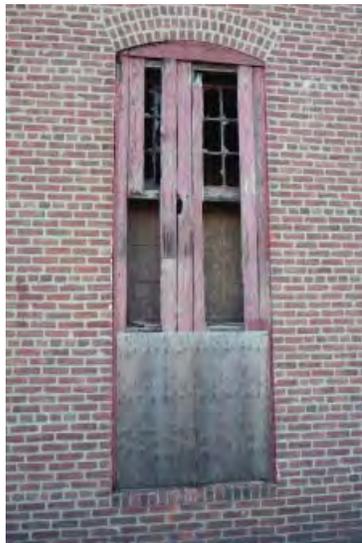
Windows have
deteriorated and are
allowing water and birds
to enter the building.

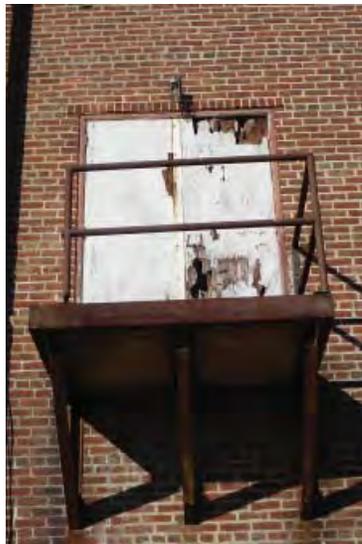
Rusted out
emergency exits.

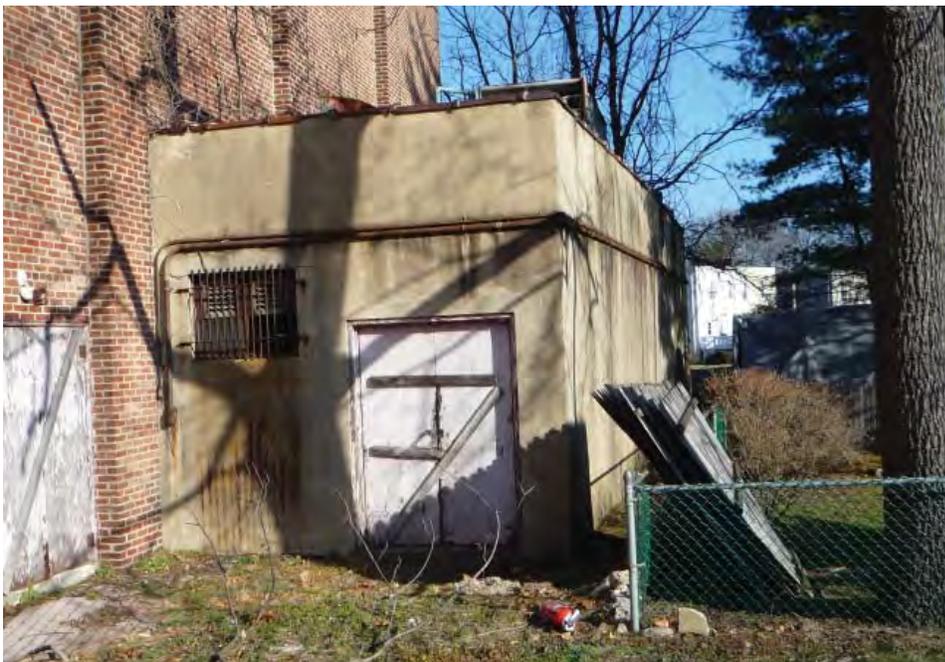
East side repaired
downspout and stained
masonry.

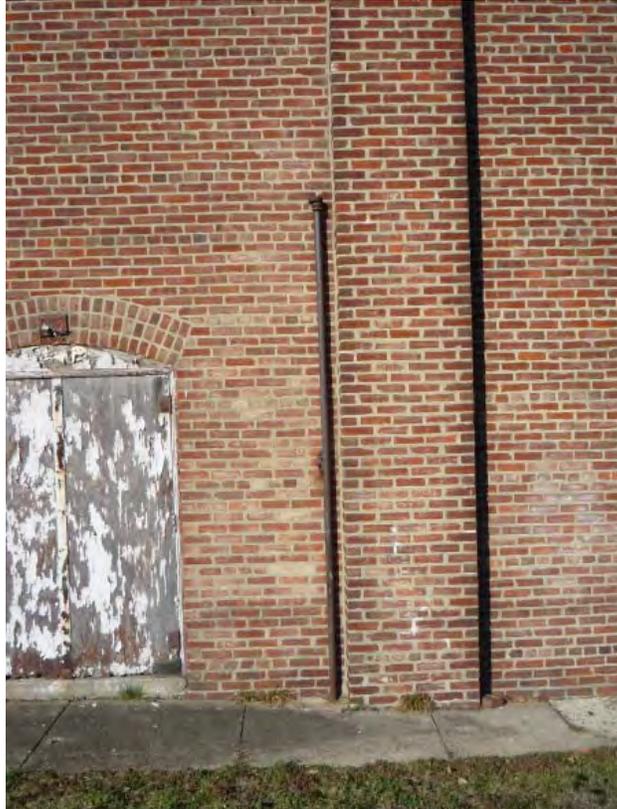
UST vent along the east side.

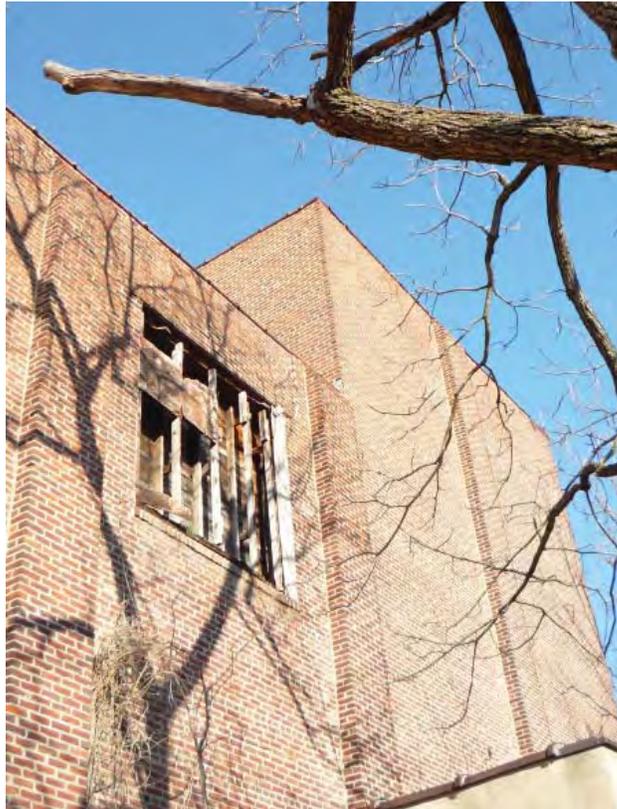
Missing upper story window. This is one of two entry points for birds and water.

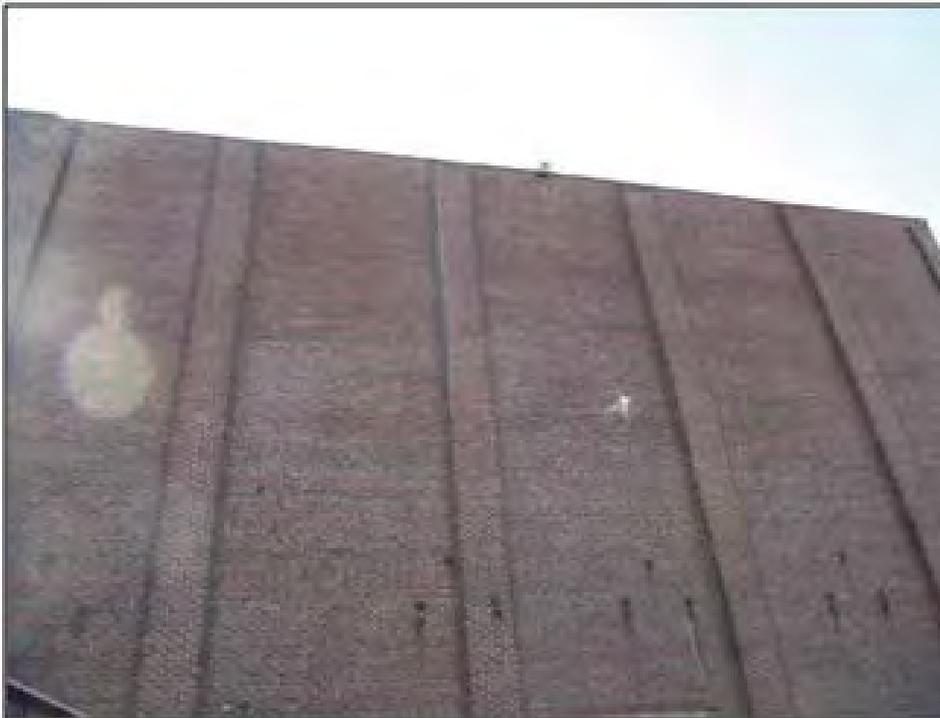
Note cracks in northeast addition .

Note vertical cracks, efflorescence bloom and wall mounted steel plates in back wall. The east side wall has several minor vertical cracks (including at the base of a pilaster) with several areas of missing mortar. The front wall has vertical cracks at the bottom southeast corner.

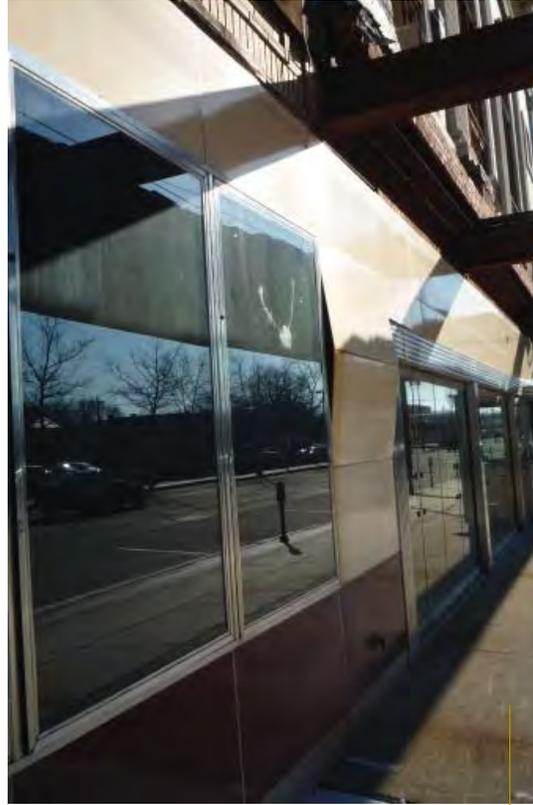
The first floor of the Front Elevation has been covered with metal panels and has damaged the beautiful deeply raked masonry. Some of the panels are coming loose and pose a safety threat to pedestrians.

- 2. Front Façade:** Following the removal of the metal panels, the building should be cleaned with an approved detergent. The bricks that have been damaged, removed and new bricks installed; windows to be replaced. Depending on availability of funding, a review of the entrance system could be undertaken together with the rationale for keeping or removing the ticket booth structure.

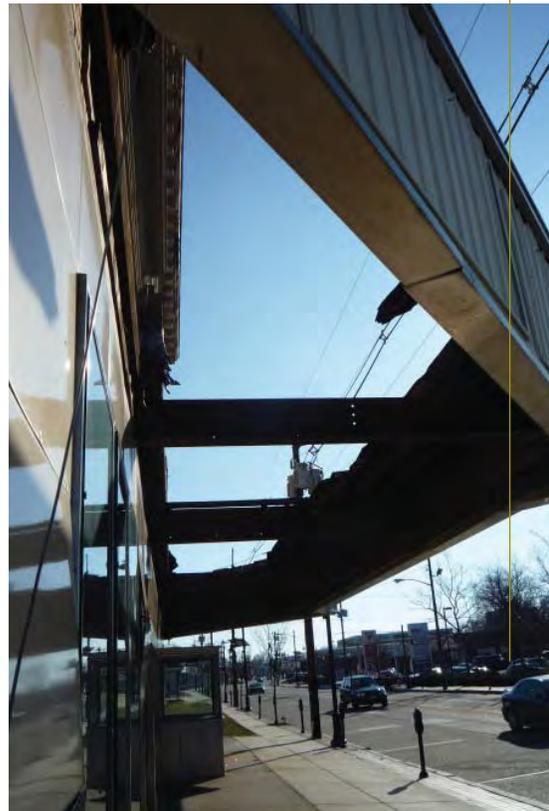
The canopy roof has completely disintegrated and is now exposing all the structural steel.

- 1. Canopy:** Documents revealed that the canopy does not reflect the one in the 1927 original building. The canopy should be removed and replaced with an appropriate flat electronic sign that would reflect the proposed use. The size should not exceed the width of the 3 central bays. The front façade should then be repaired with the same bricks and care taken to ensure a perfect match with the Portland cement mortar.

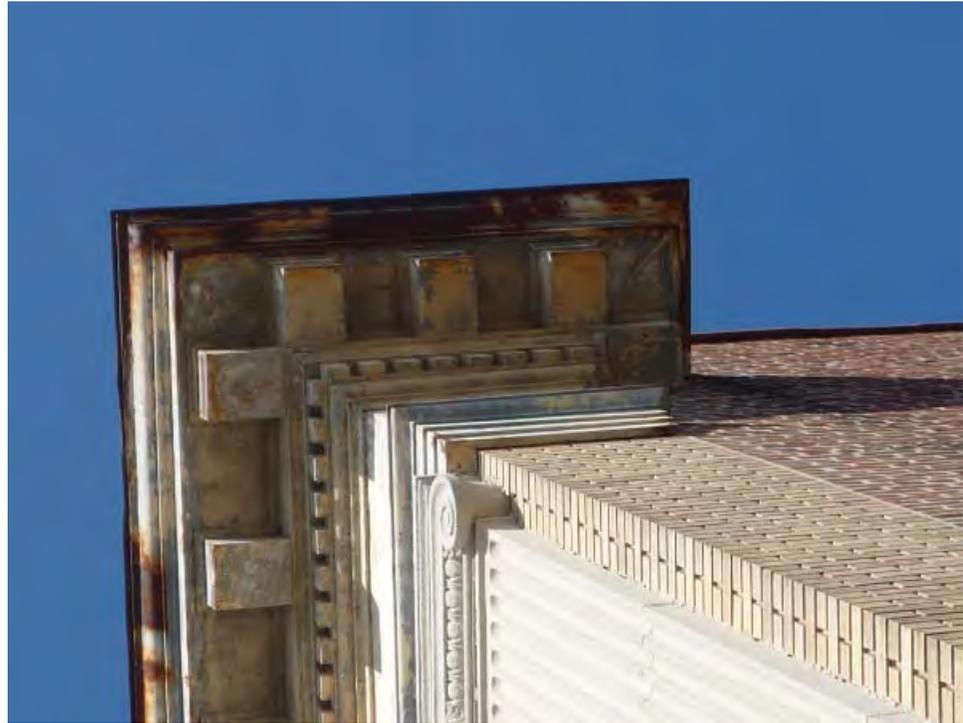
Soffit modillions are starting to rust out.

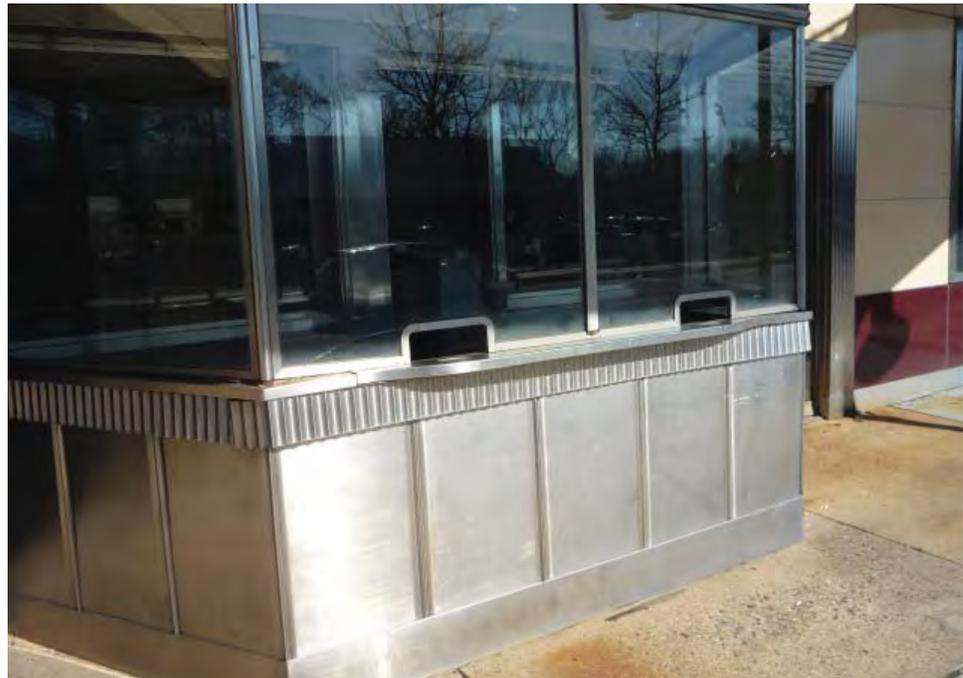
Ticket booth projects into sidewalk.
